St Michael's – Works Commence On Site

St Michael's – A Rejuvenation

St. Michael's Church, Enniskillen A Rejuvenation

Facade Repairs

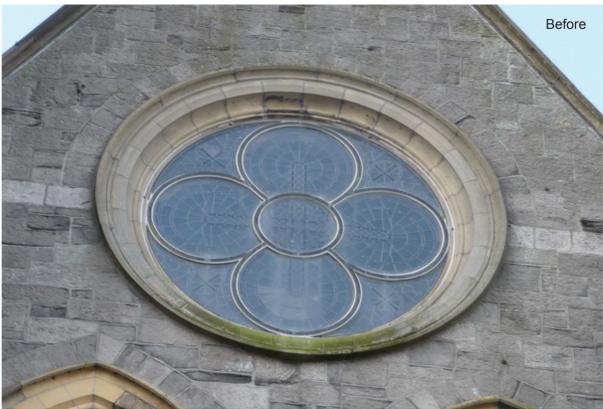
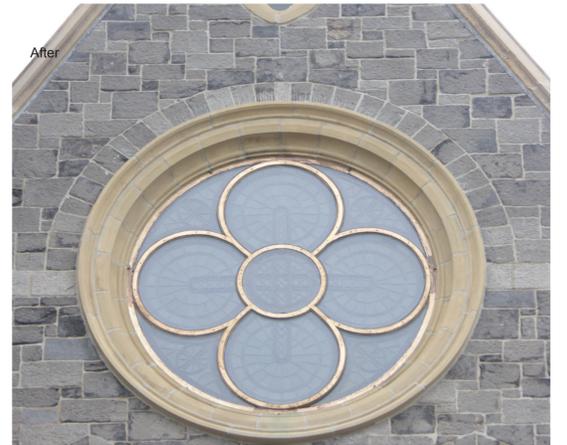
Glass Cleaning & Repairs
All the existing stained glass windows on the main building facade have been carefully and expertly cleaned down and repaired where necessary. The brass work on the Rose windows has also been repaired and cleaned.

Storm Glazing
The old defective storm glazing has been removed and replaced with new safety clear glazing fixed in place with specially crafted brass fixing bolts. The completion of the windows have provided a shape new appearance to the building facade.

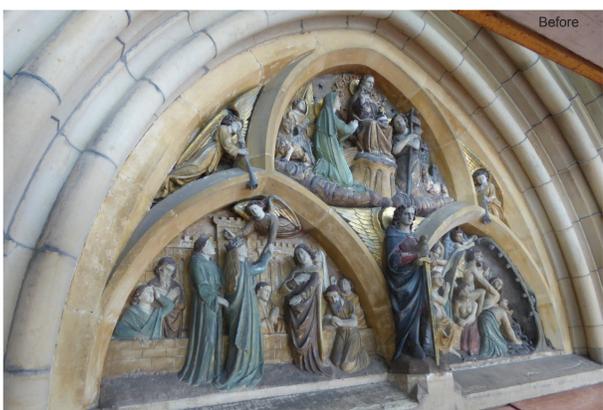
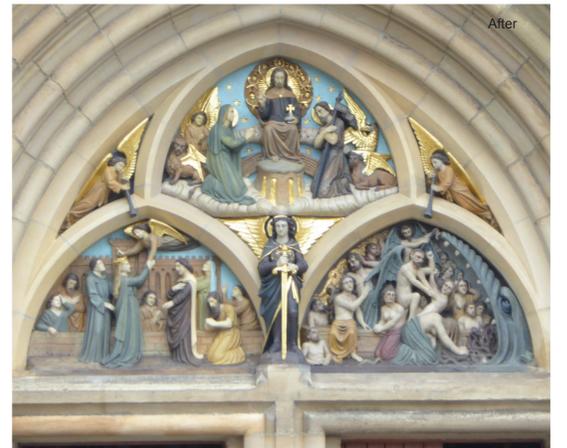
An expert artist was employed to complete the repair and restoration of the Tympanum above the main entrance to St Michaels Church. Monica Liddle from Emyvale in County Monaghan has extensive experience in restoration of sacred artwork on old church buildings.

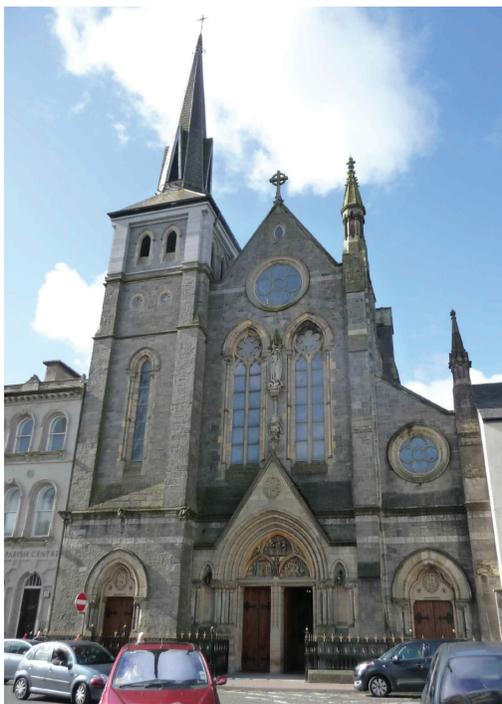
before

Several years ago Parish put plans in place to address this deterioration but did not proceed with them conscious of more urgent demands on scarce resources. All changed earlier this year however when serious cracking of the stone was identified with the potential to fall and cause serious injury. The repair of the historic stonework had now become a straightforward, urgent matter of public safety.

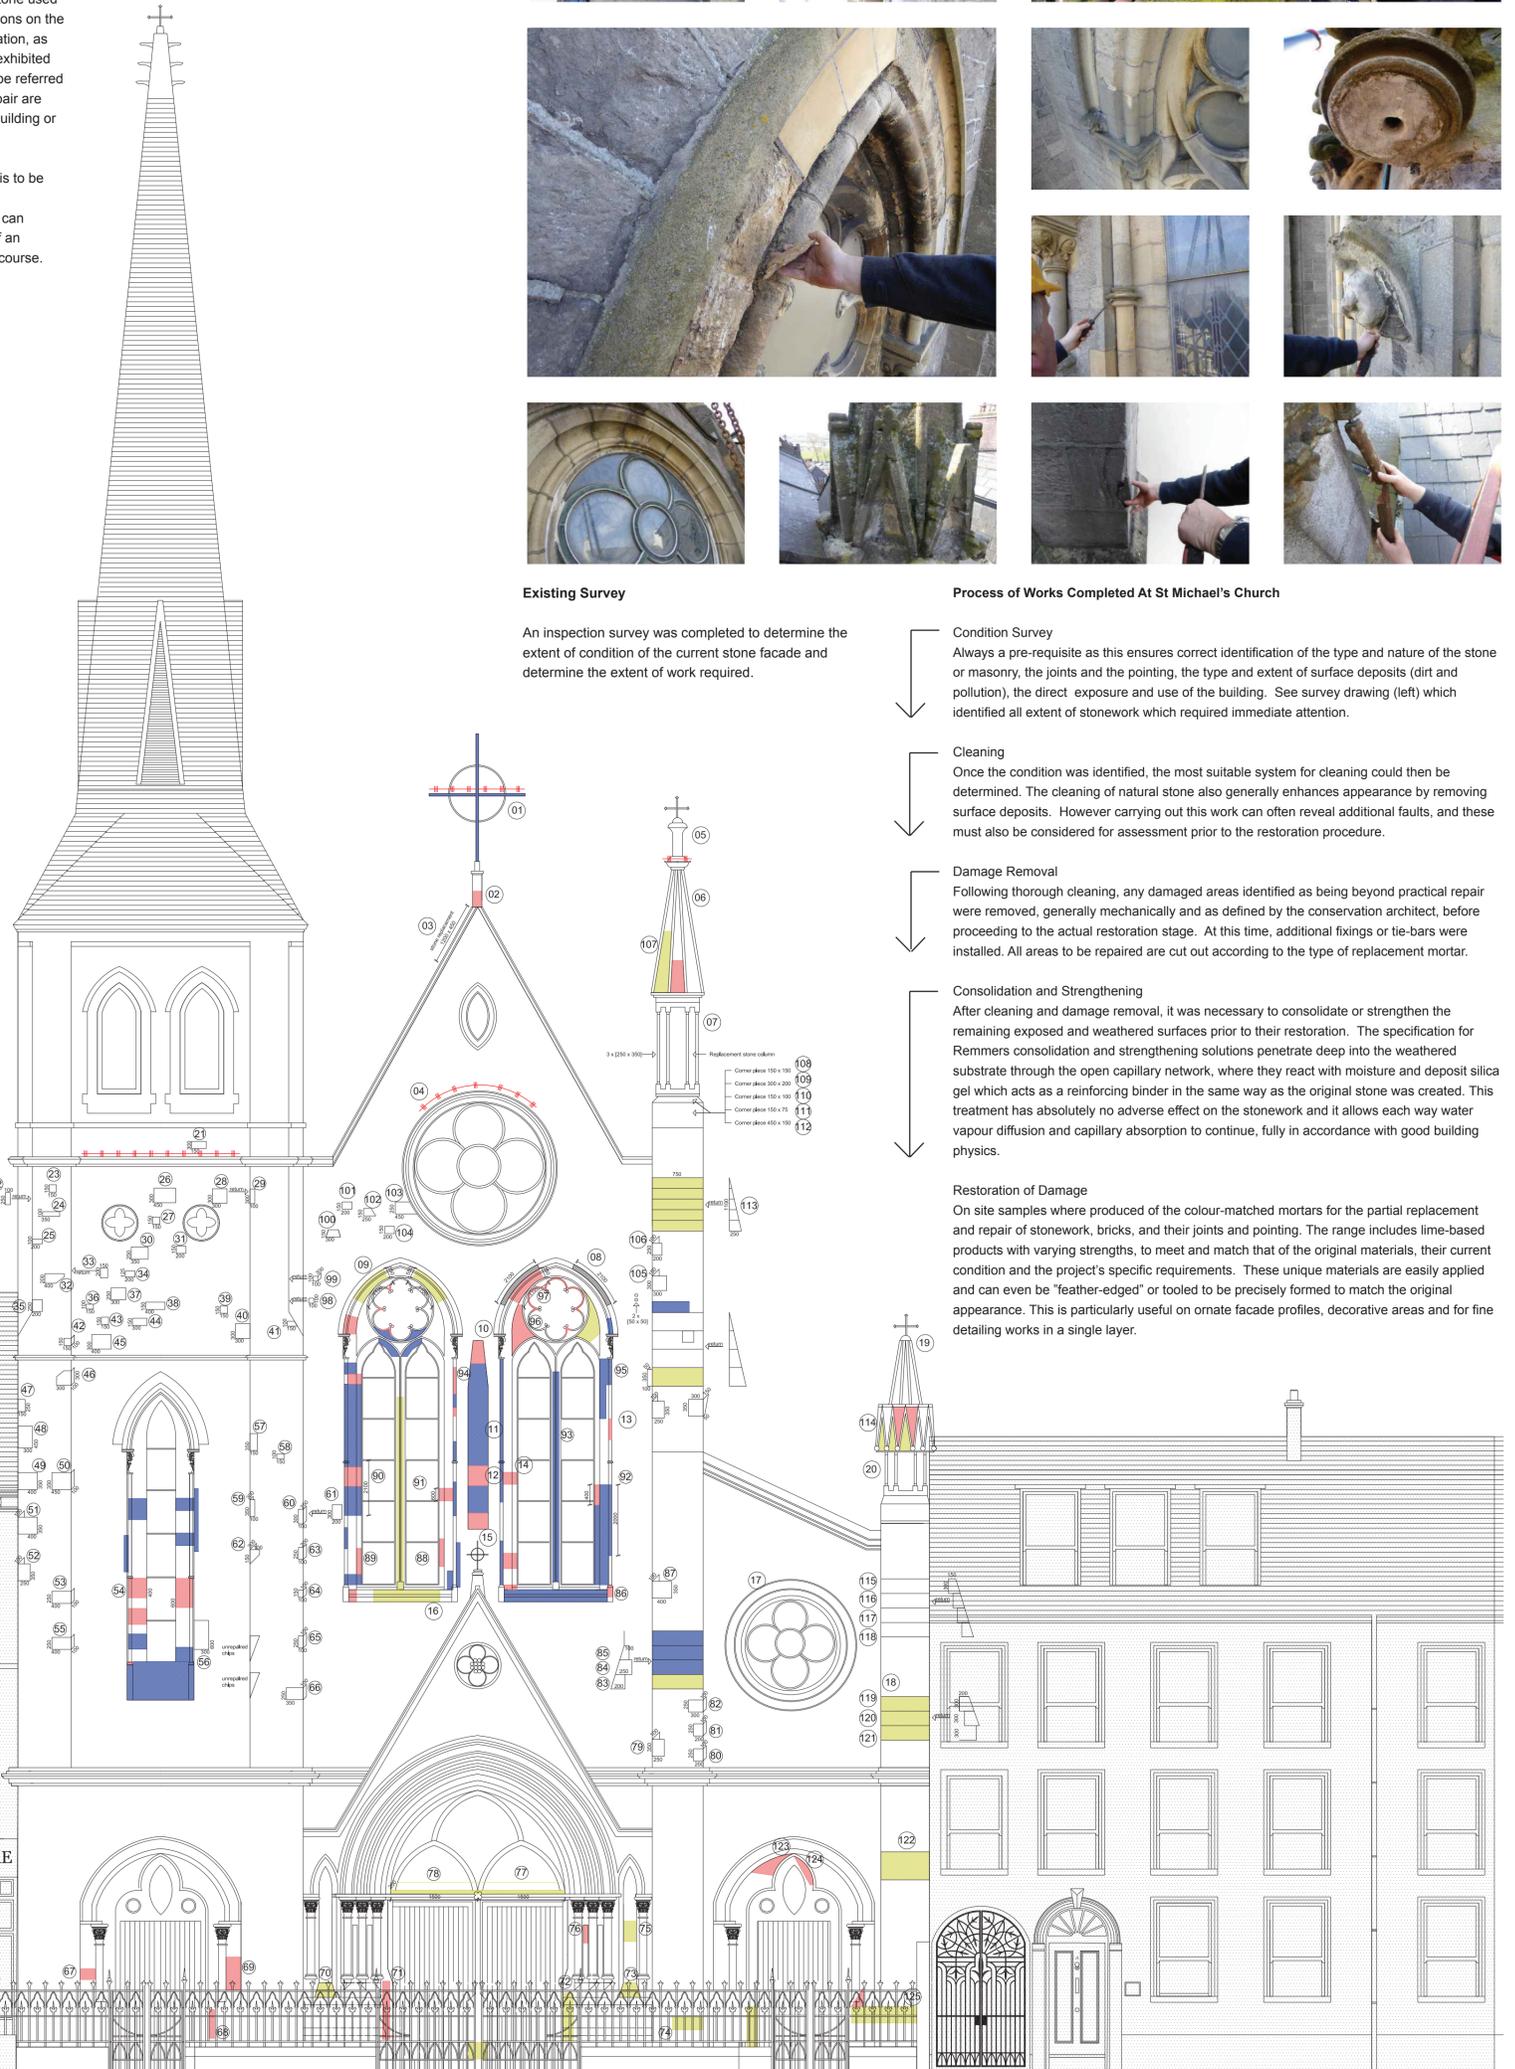
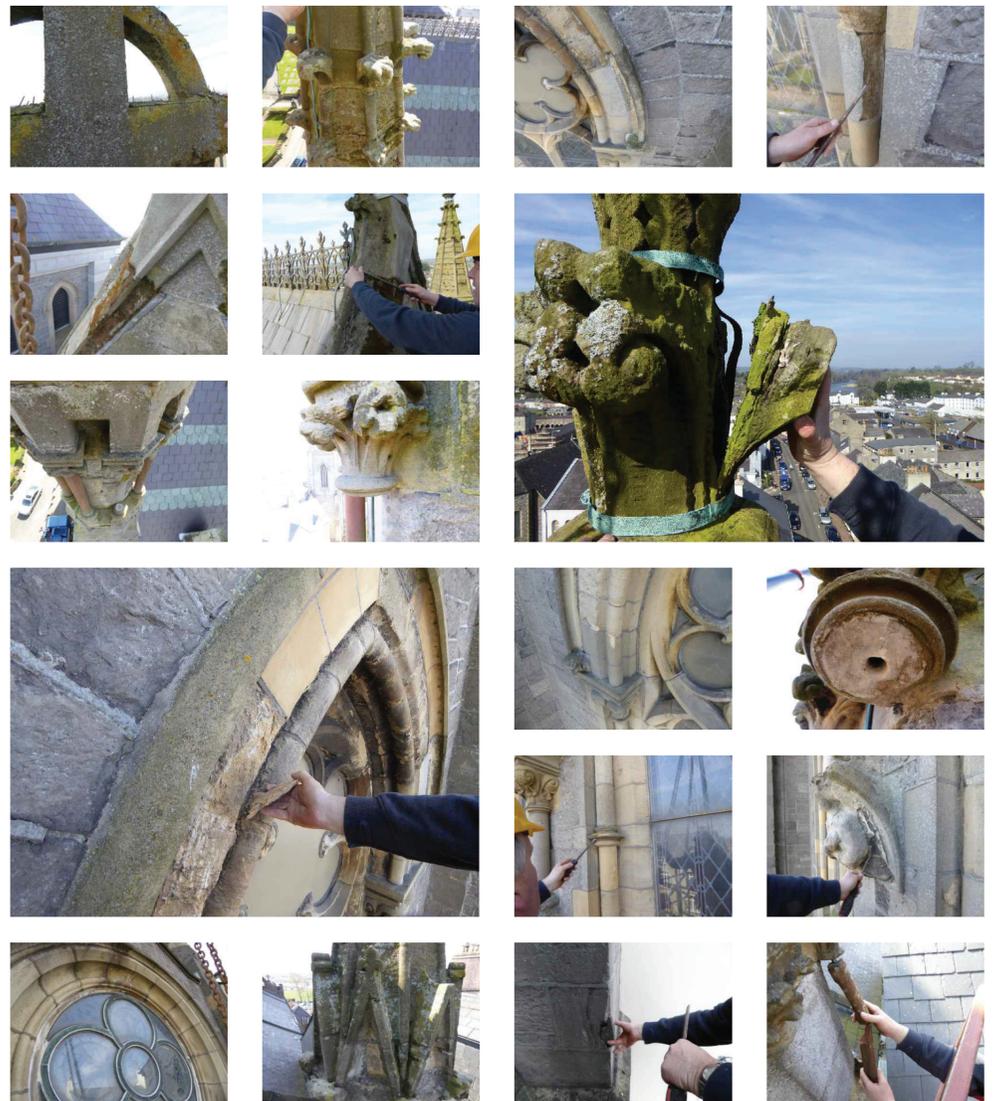
Existing Survey

An inspection survey was completed to determine the extent of condition of the current stone facade and determine the extent of work required.

- Condition Survey
Always a pre-requisite as this ensures correct identification of the type and nature of the stone or masonry, the joints and the pointing, the type and extent of surface deposits (dirt and pollution), the direct exposure and use of the building. See survey drawing (left) which identified all extent of stonework which required immediate attention.

- Cleaning
Once the condition was identified, the most suitable system for cleaning could then be determined. The cleaning of natural stone also generally enhances appearance by removing surface deposits. However carrying out this work can often reveal additional faults, and these must also be considered for assessment prior to the restoration procedure.

- Damage Removal
Following thorough cleaning, any damaged areas identified as being beyond practical repair were removed, generally mechanically and as defined by the conservation architect, before proceeding to the actual restoration stage. At this time, additional fixings or tie-bars were installed. All areas to be repaired are cut out according to the type of replacement mortar.

- Consolidation and Strengthening
After cleaning and damage removal, it was necessary to consolidate or strengthen the remaining exposed and weathered surfaces prior to their restoration. The specification for Remmers consolidation and strengthening solutions penetrate deep into the weathered substrate through the open capillary network, where they react with moisture and deposit silica gel which acts as a reinforcing binder in the same way as the original stone was created. This treatment has absolutely no adverse effect on the stonework and it allows each way water vapour diffusion and capillary absorption to continue, fully in accordance with good building physics.

- Restoration of Damage
On site samples were produced of the colour-matched mortars for the partial replacement and repair of stonework, bricks, and their joints and pointing. The range includes lime-based products with varying strengths, to meet and match that of the original materials, their current condition and the project's specific requirements. These unique materials are easily applied and can even be "feather-edged" or tooled to be precisely formed to match the original appearance. This is particularly useful on ornate facade profiles, decorative areas and for fine detailing works in a single layer.
