St Michael's – Works Commence On Site

St Michael's – A Rejuvenation

St. Michael's Church, Enniskillen A Rejuvenation

Facade Repairs

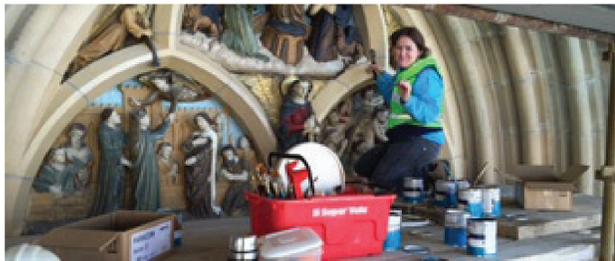
St Michael's – Tympanum

An expert artist was employed to complete the repair and restoration of the Tympanum above the main entrance to St Michaels Church. Monica Liddle from Emyvale in County Monaghan has extensive experience in restoration of sacred artwork on old church buildings.

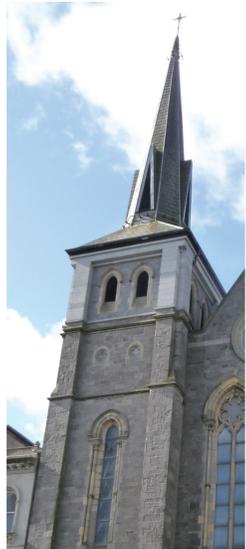
KEY	
	Remove mortar and repoint lime mortar
	Buff stone
	Mortar repair
	Colour wash
	Bird repellent tape

An inspection survey was completed to determine the extent of condition of the current stone facade and determine the extent of work required.
